PRESTRESSED CONCRETE TEE BEAMS WITH  
LARGE WEB OPENINGS

A THESIS

DEPARTMENT OF CIVIL ENGINEERING  
EDMONTON, ALBERTA

FALL, 1970

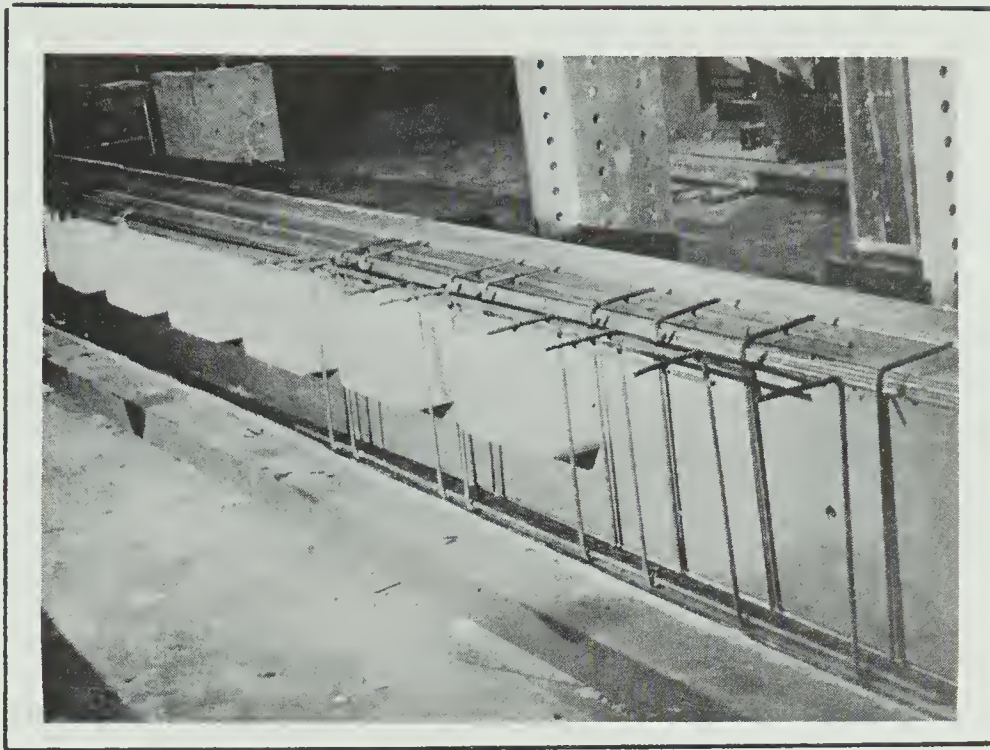
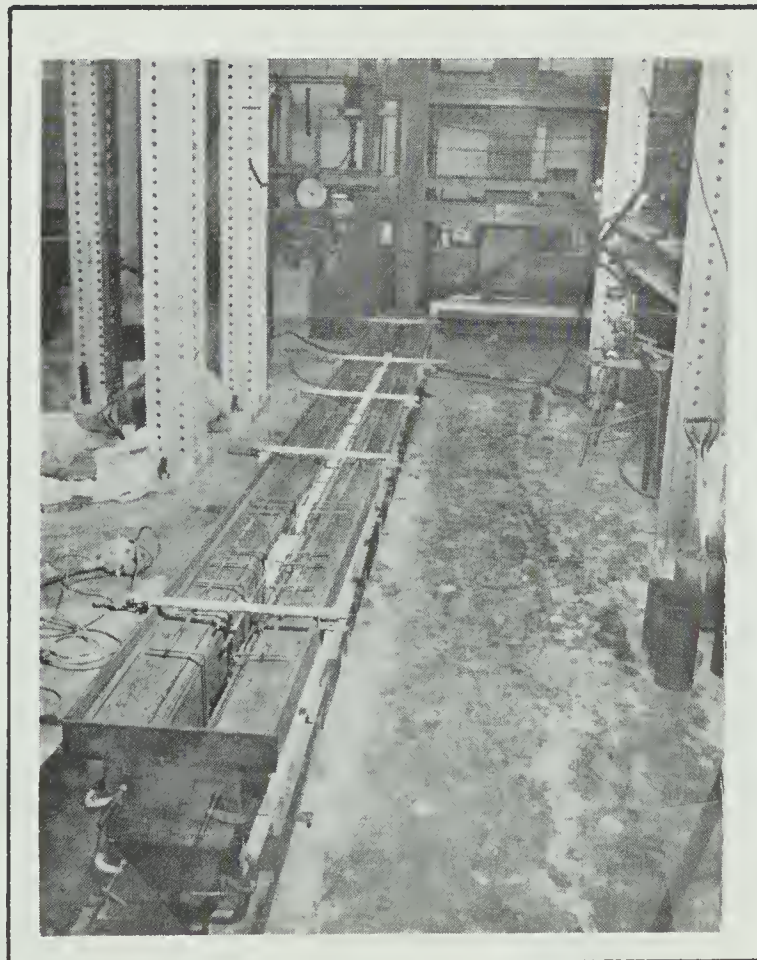
FIGURE A.4 FORMWORK

After the concrete had set for 24 hours, the exterior forms were unbolted and slipped off while the interior forms were peeled off the hardened concrete. The styrofoam blocks were then punched through. This method worked extremely well and is recommended for future casting operations.

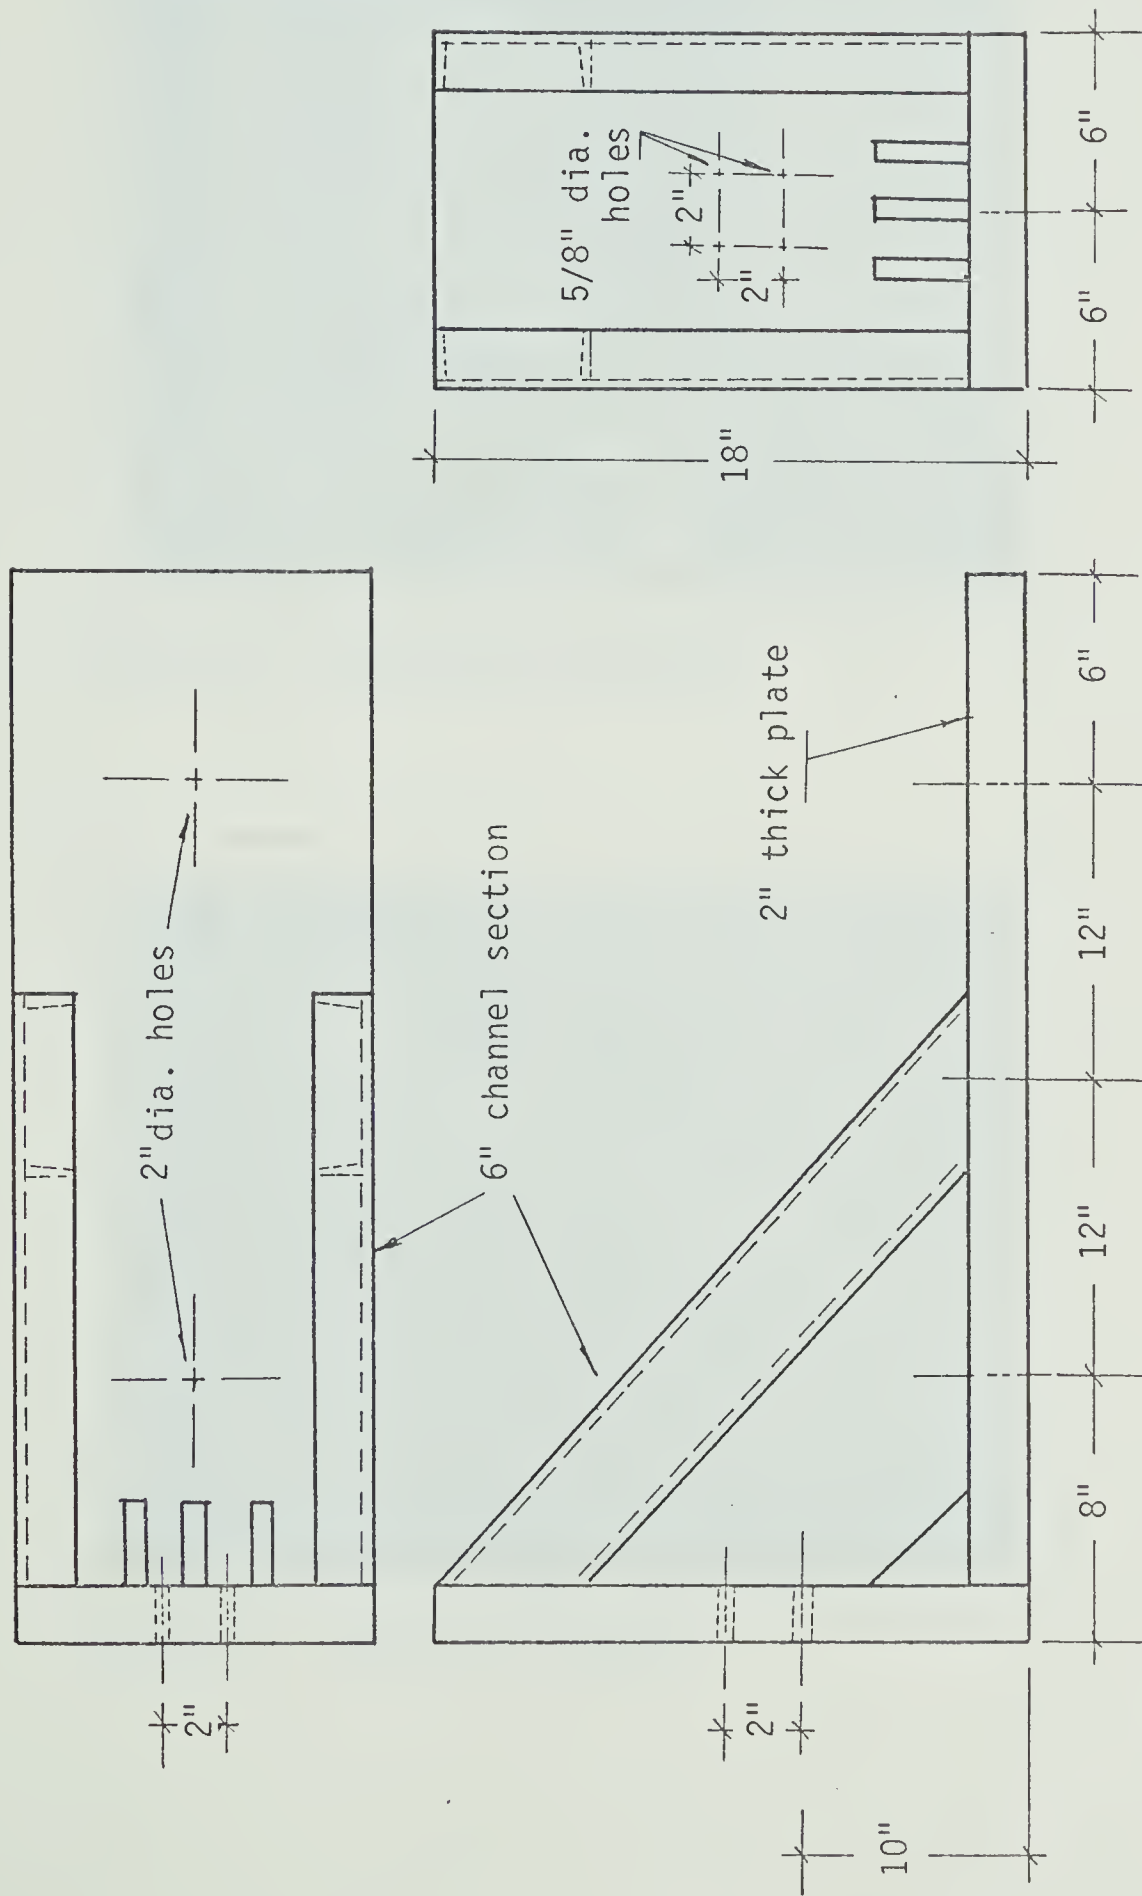
FIGURE A.5 ALL STEEL PRESTRESSING ABUTMENTS

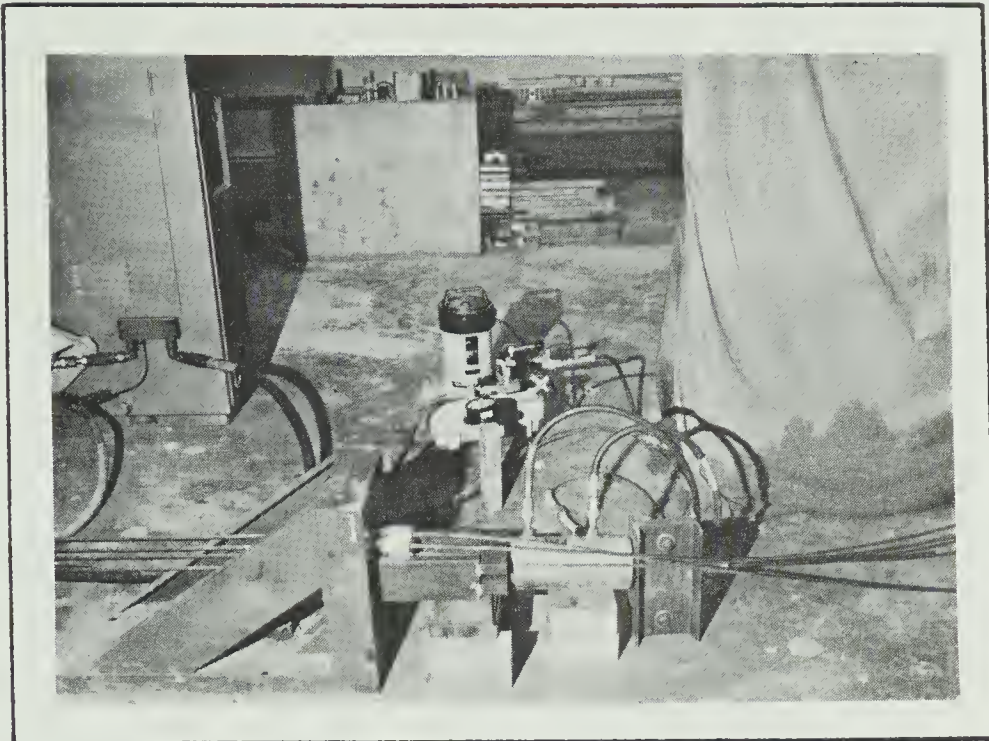
FIGURE A.6 PRESTRESSING EQUIPMENT

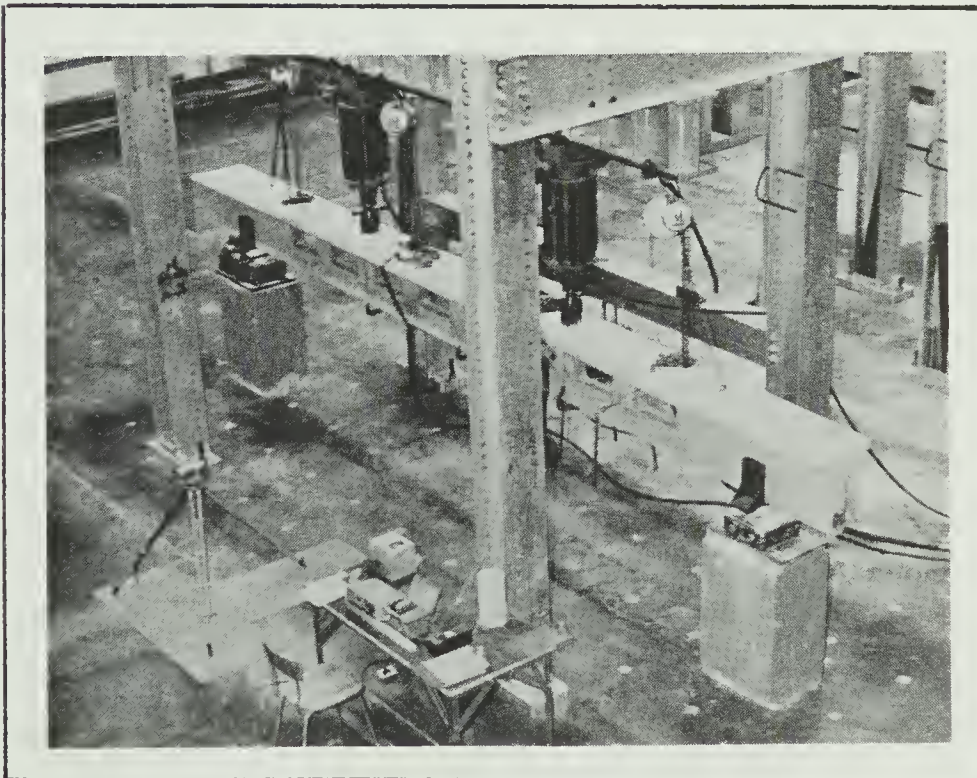
FIGURE A.7 TYPICAL TEST SET-UP

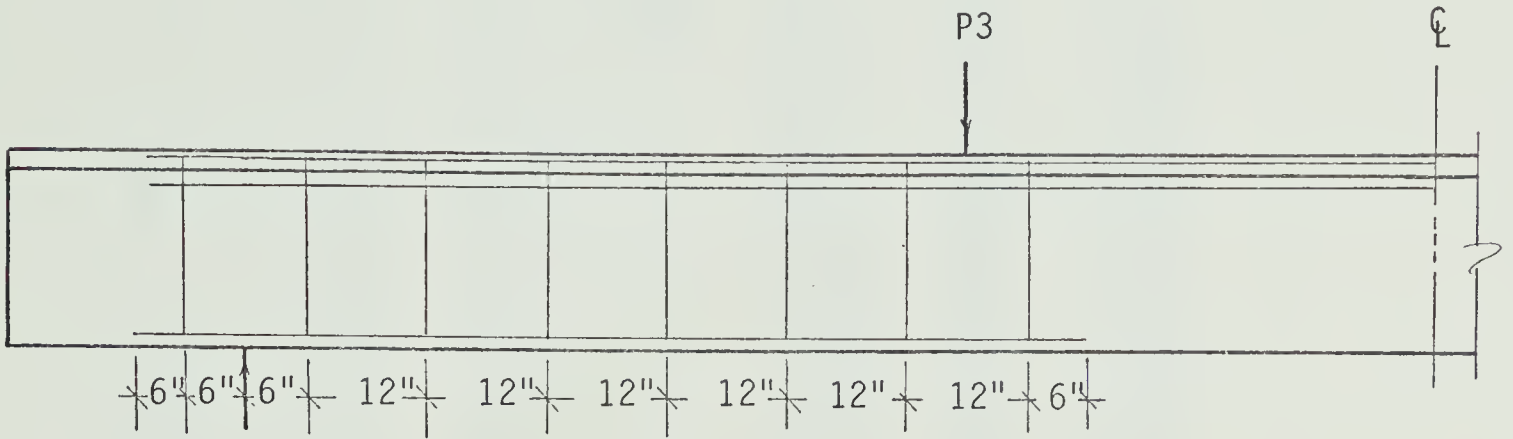
BEAM #1 REINFORCEMENT DETAIL

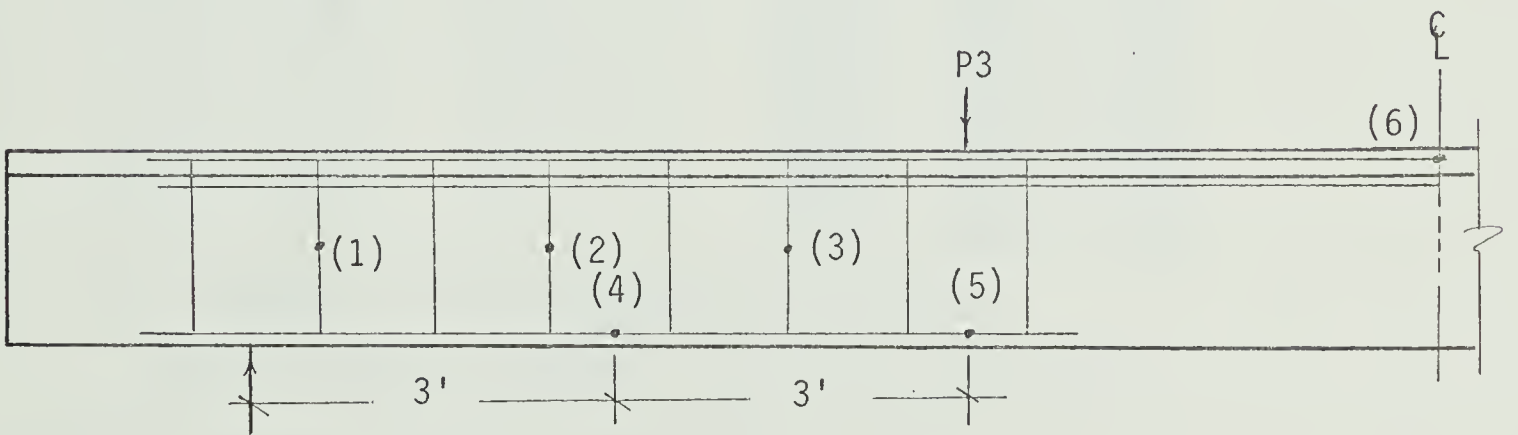
BEAM #1 STRAIN GAGE LOCATIONS

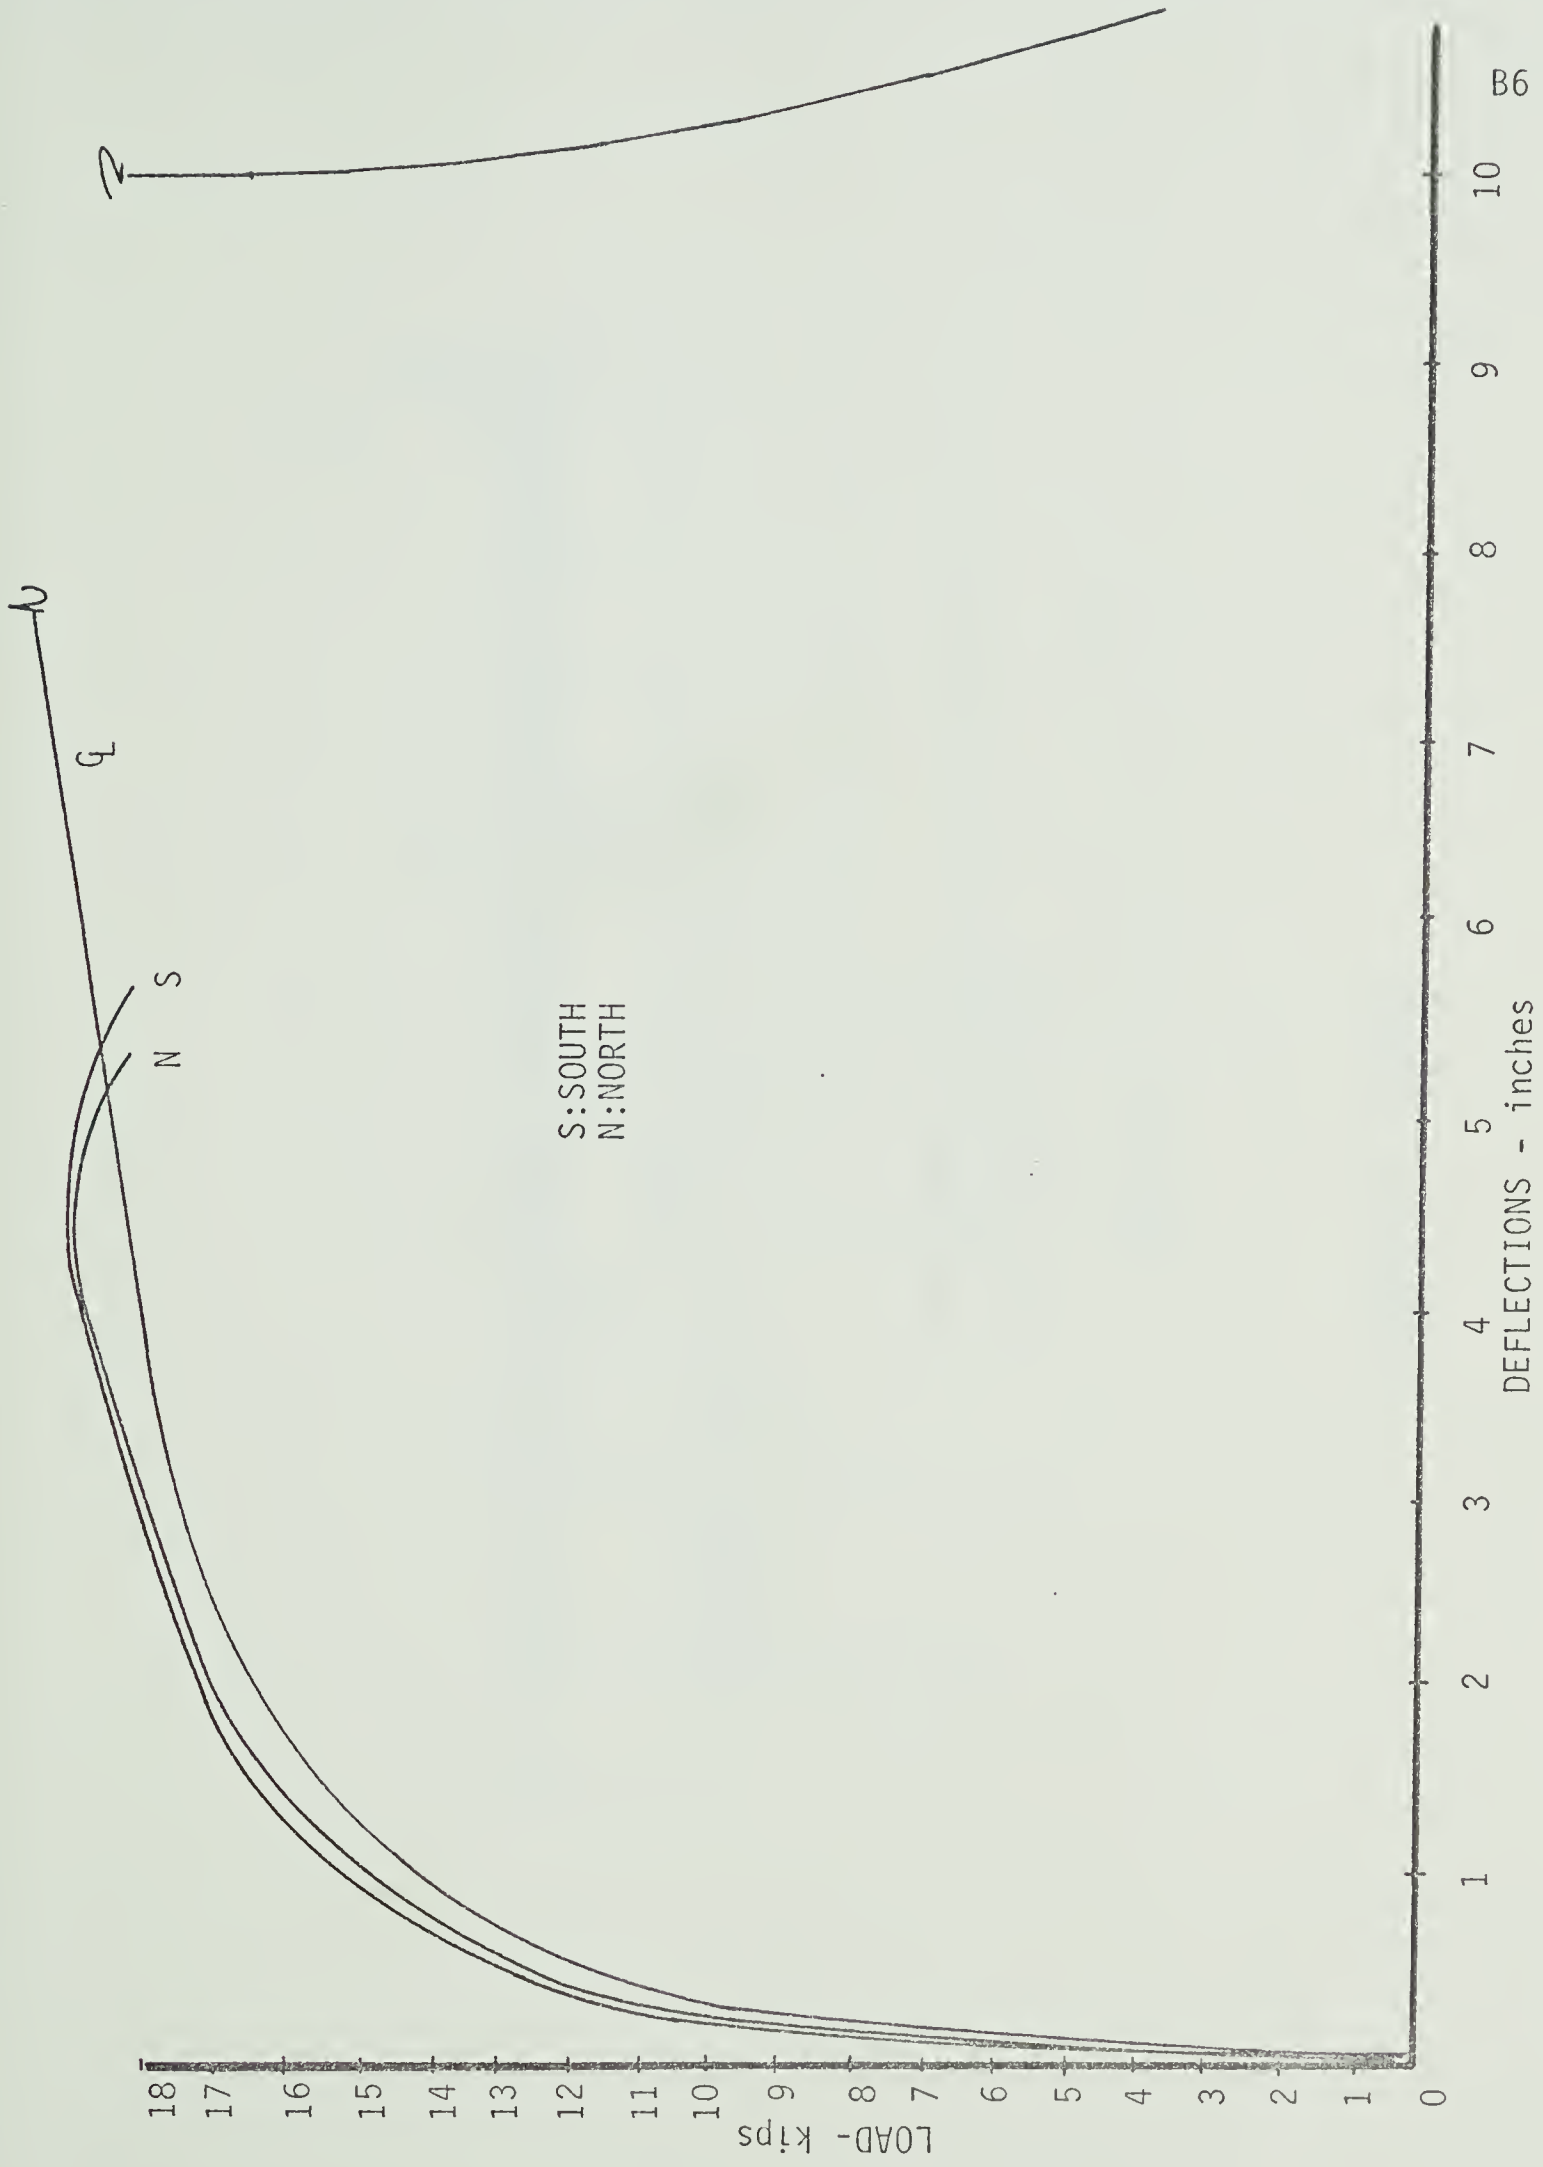
FIGURE B.1.2 LOAD-DEFLECTION DIAGRAM, BEAM #1

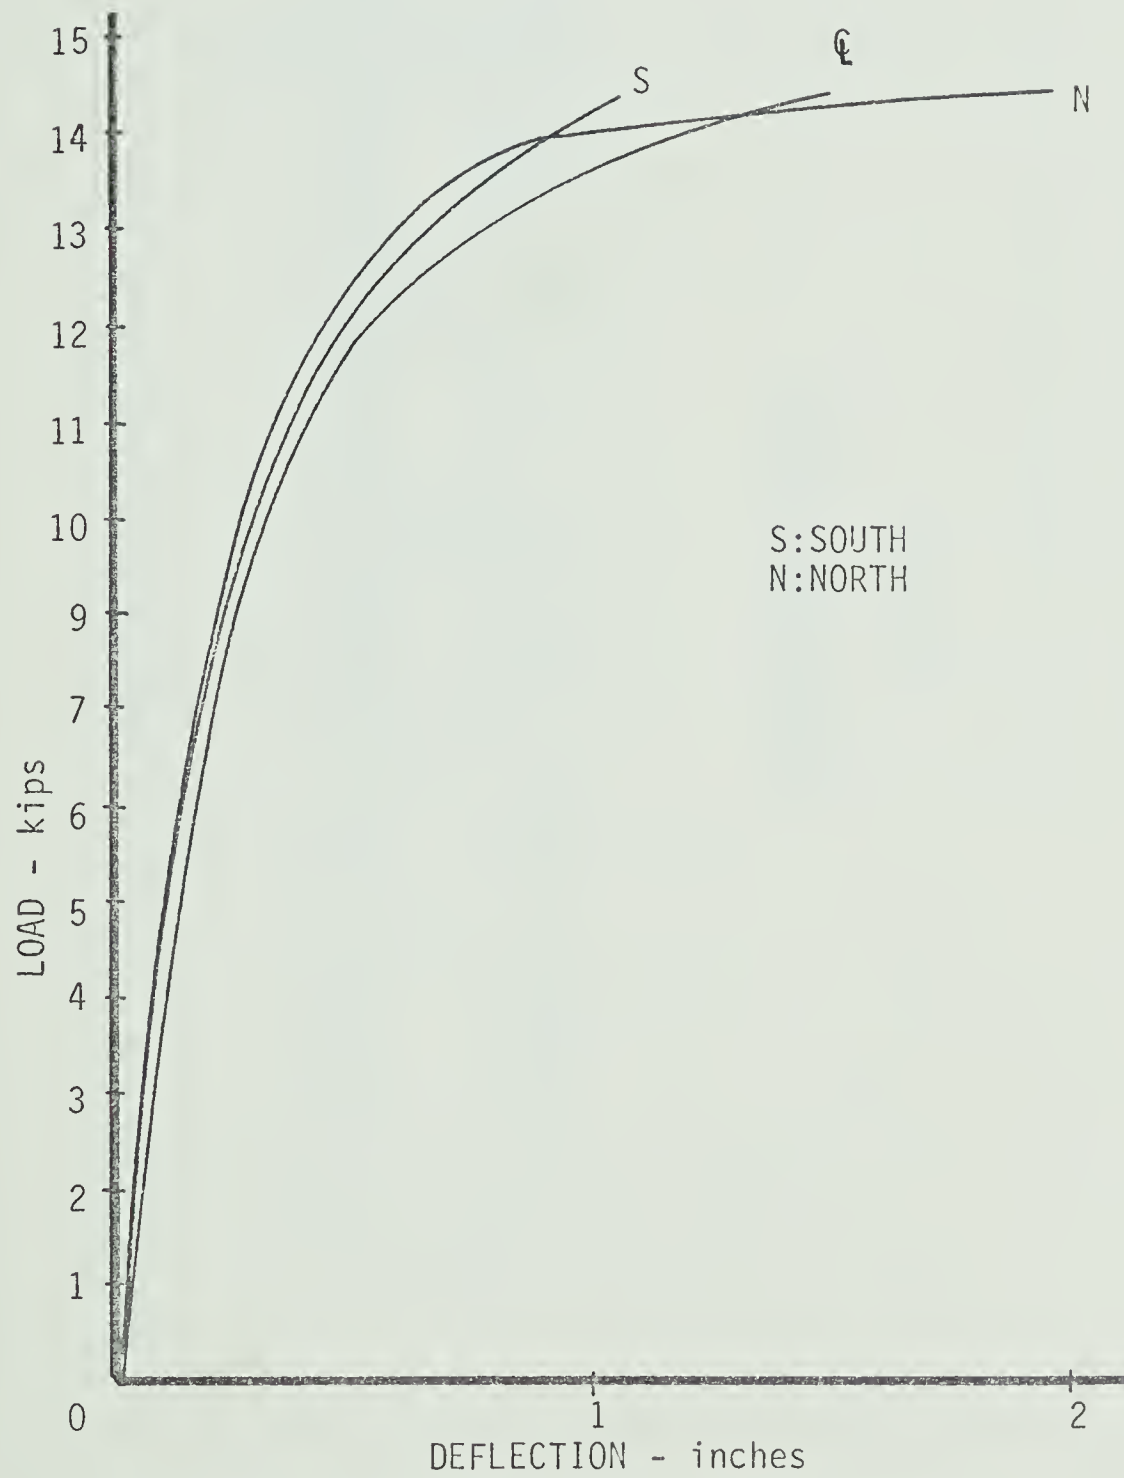
FIGURE B.2.2 LOAD-DEFLECTION DIAGRAM, BEAM #2

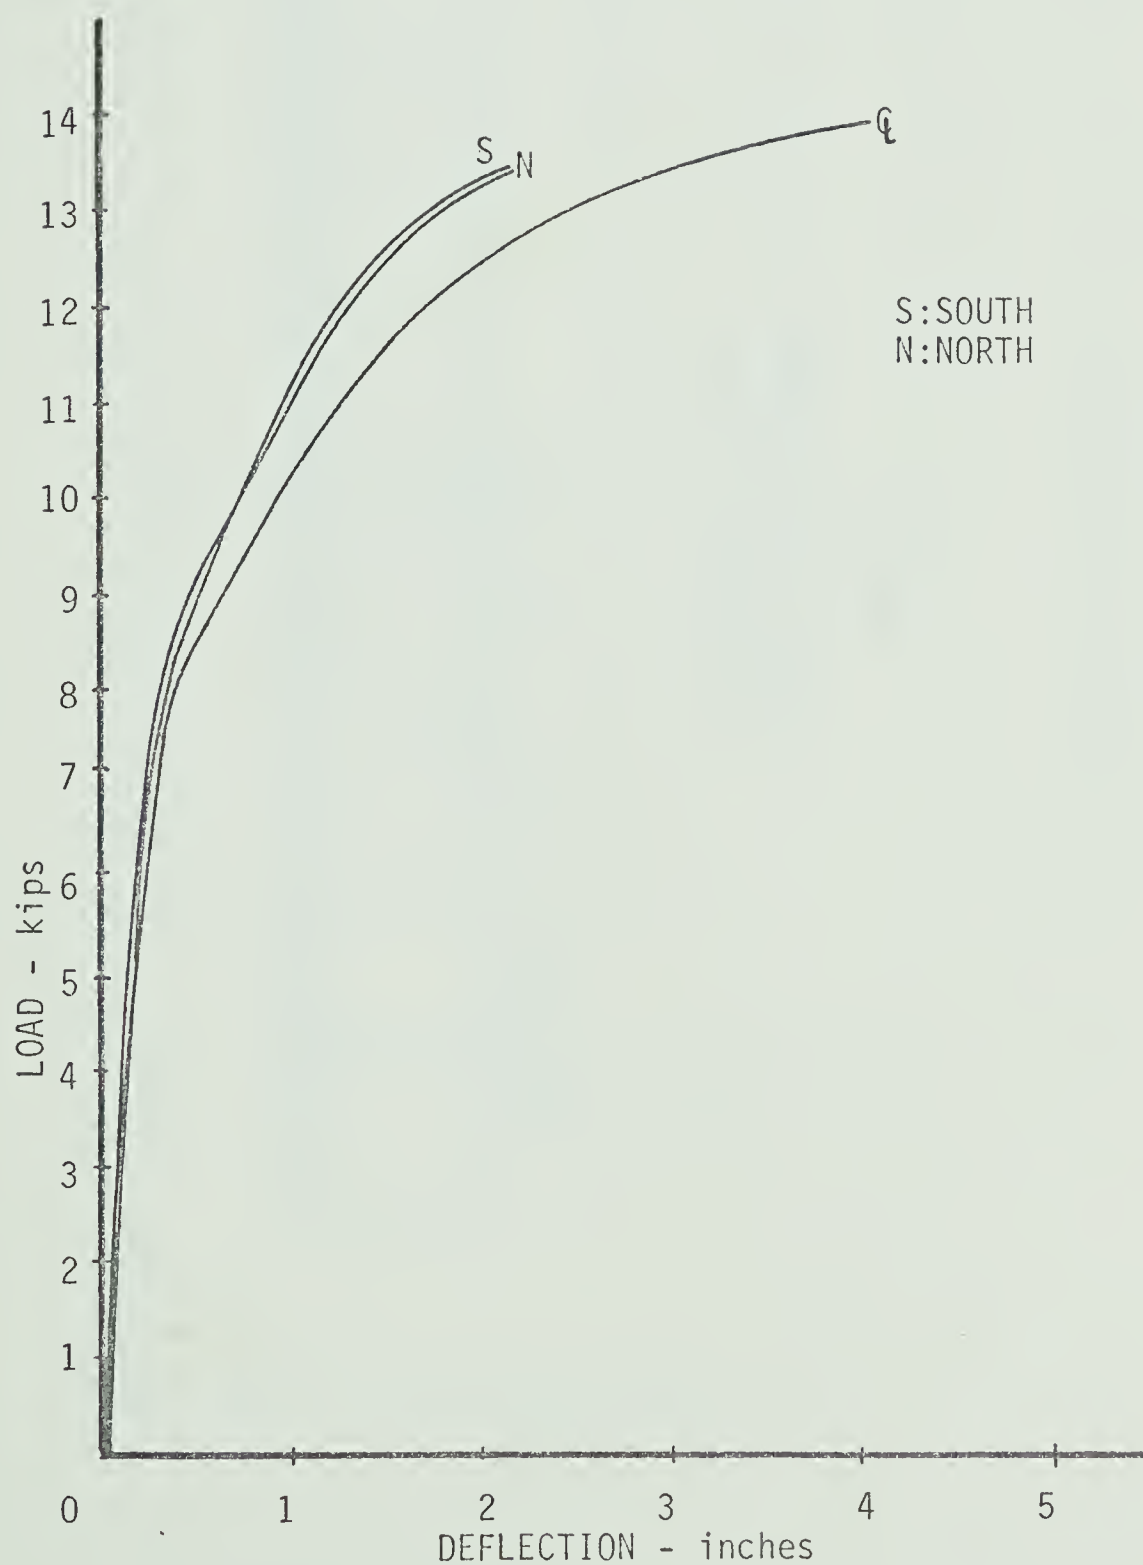
FIGURE B.3.2 LOAD-DEFLECTION DIAGRAM, BEAM #3

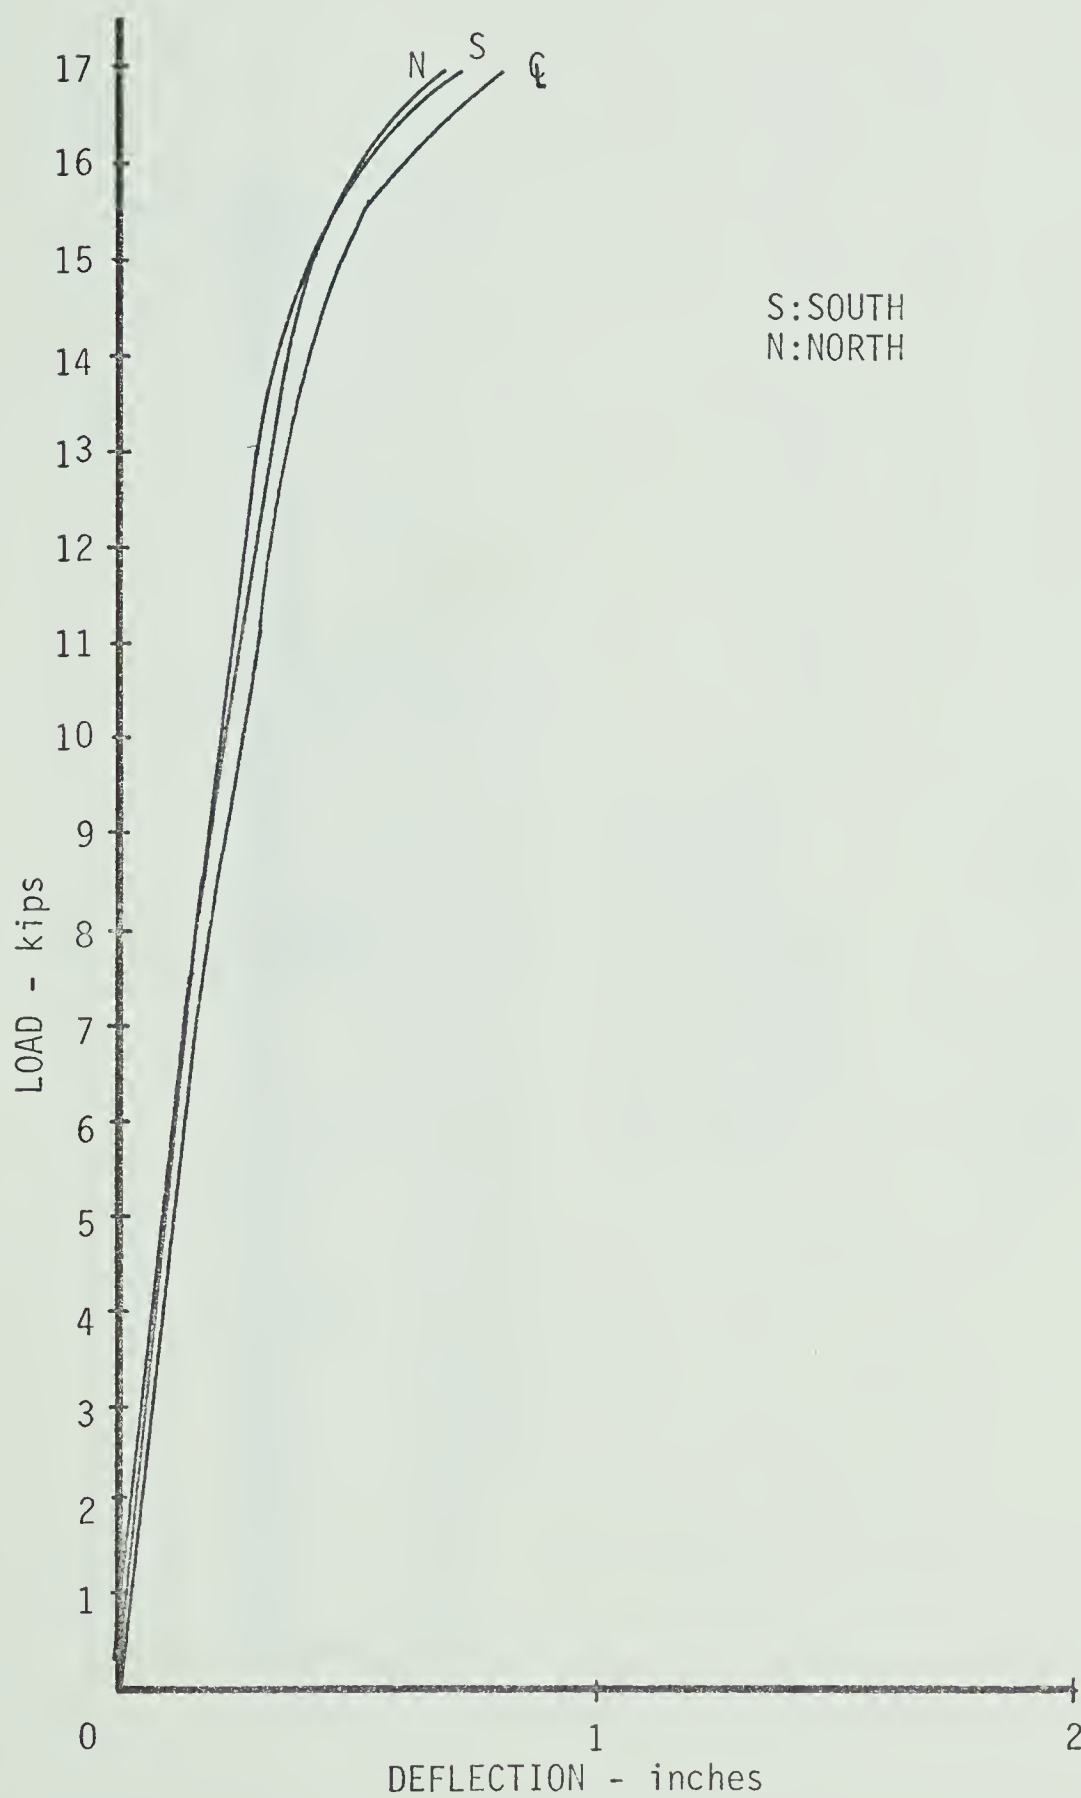
FIGURE B.4.2 LOAD-DEFLECTION DIAGRAM, BEAM #4

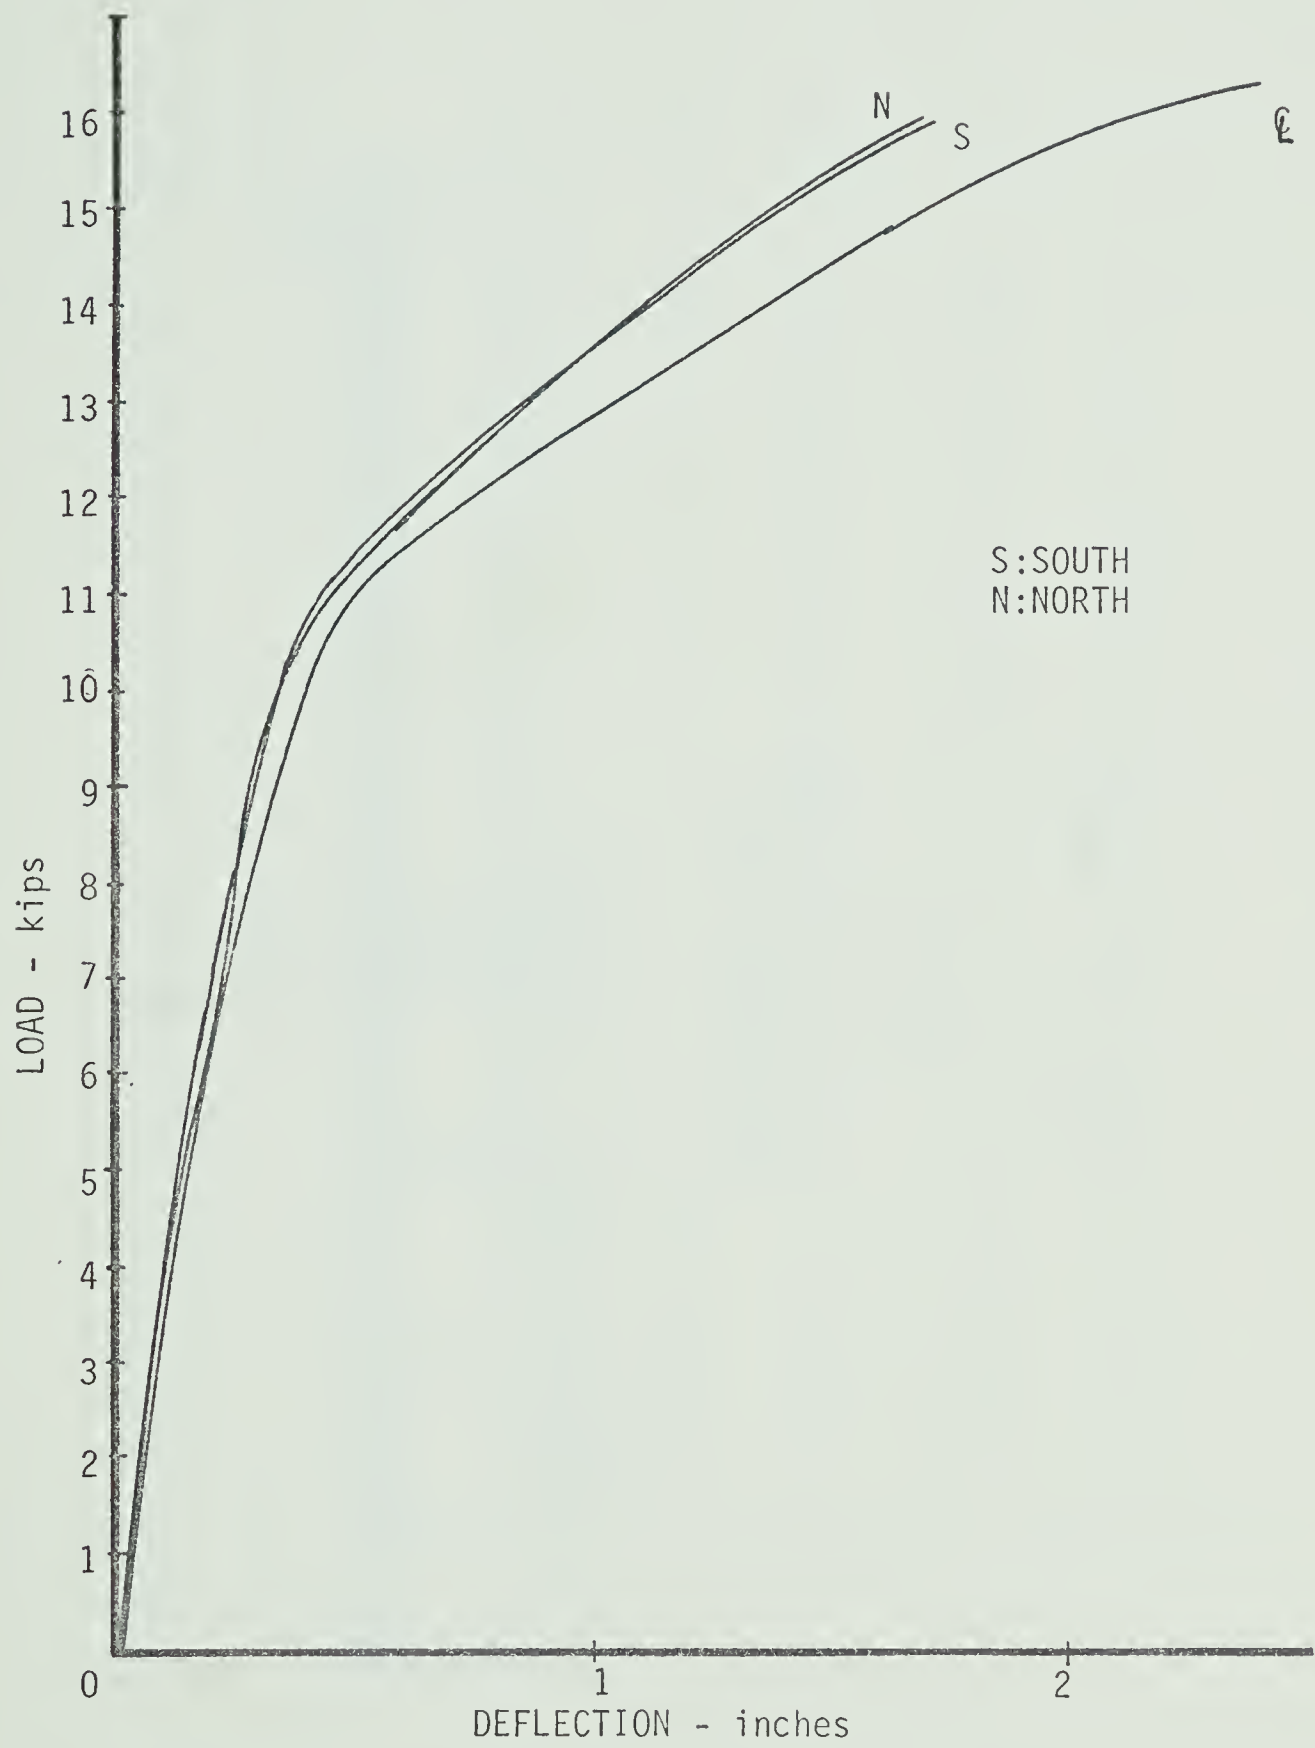
FIGURE B.5.2 LOAD-DEFLECTION DIAGRAM, BEAM #5

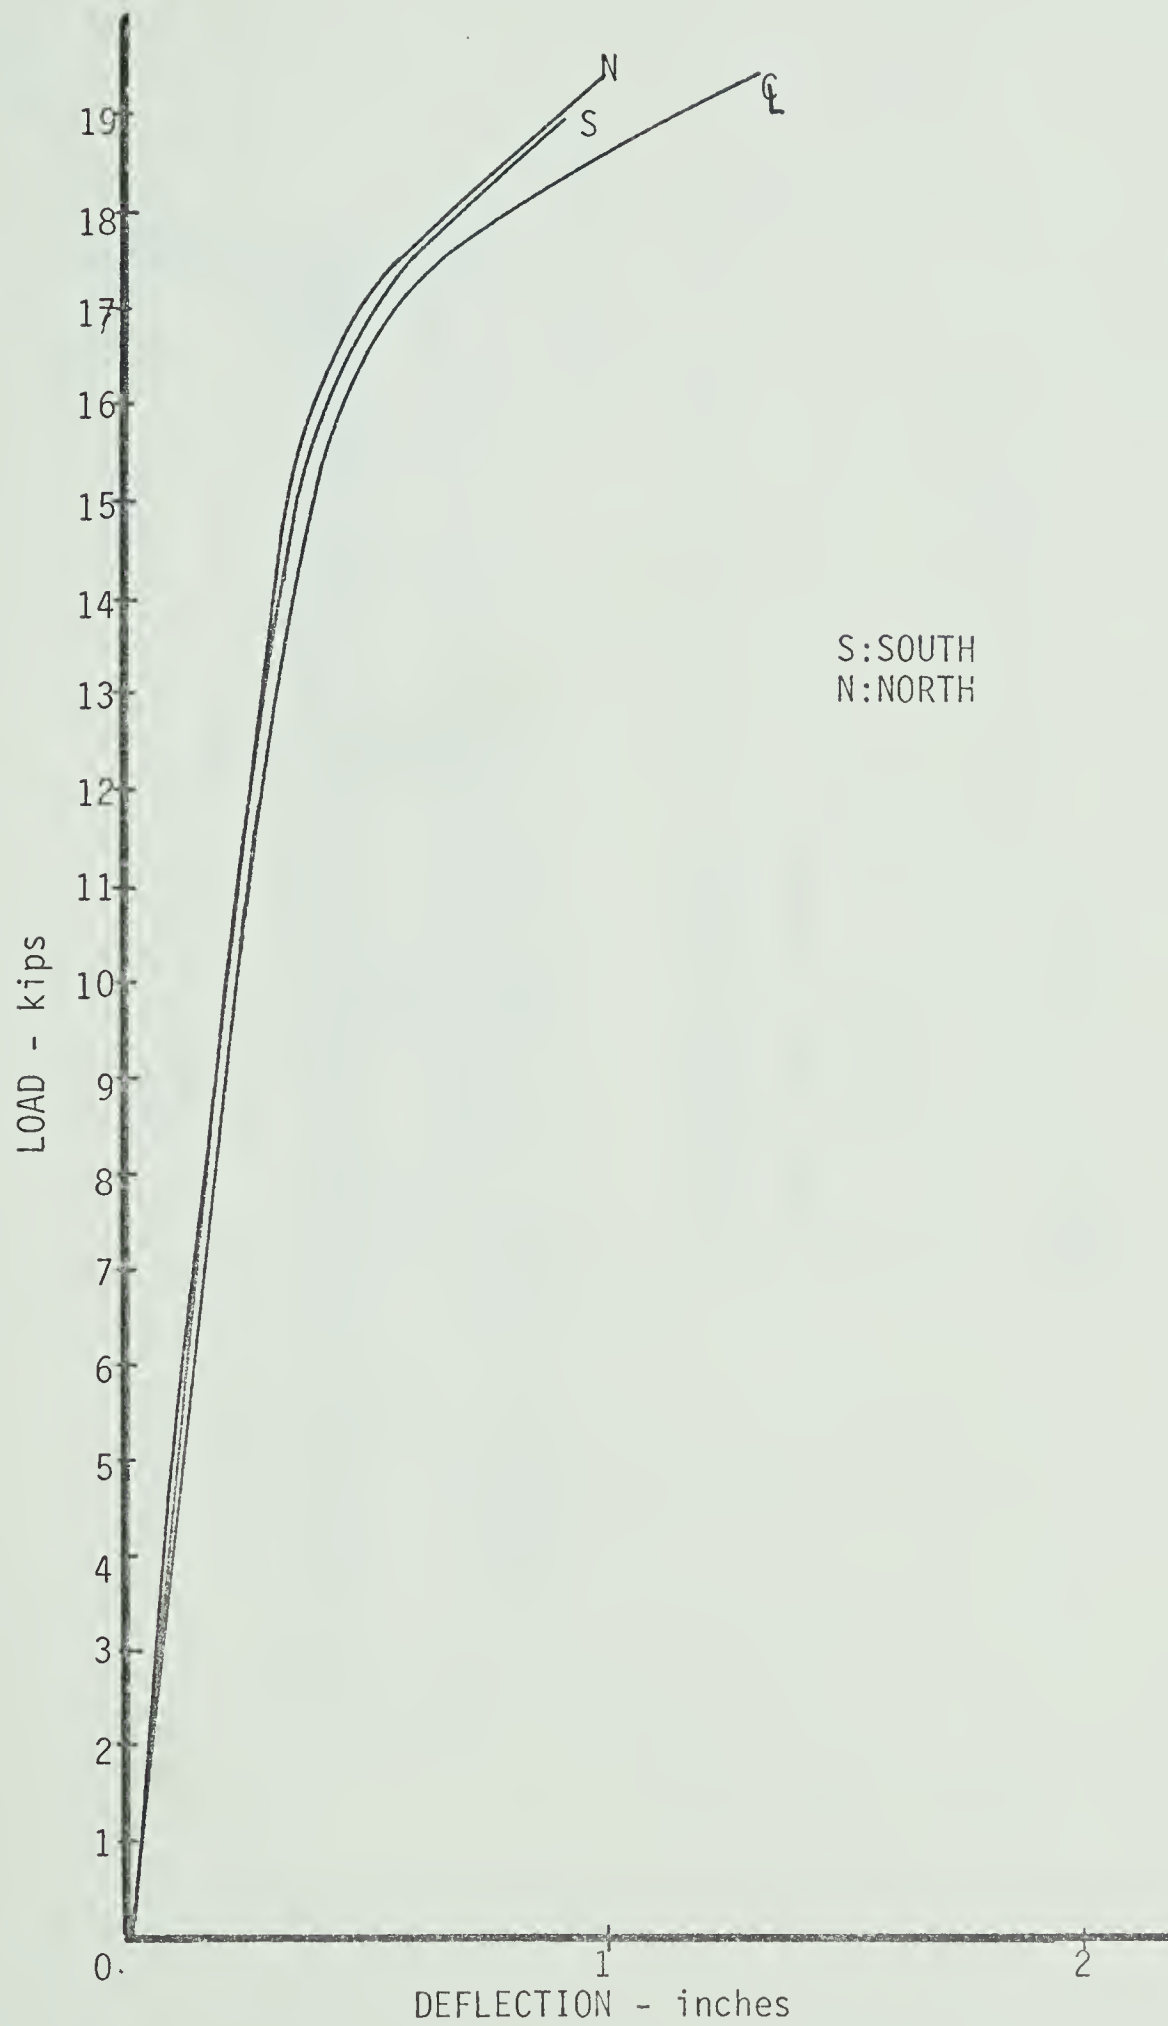
FIGURE B 6.2 LOAD-DEFLECTION DIAGRAM, BEAM #6

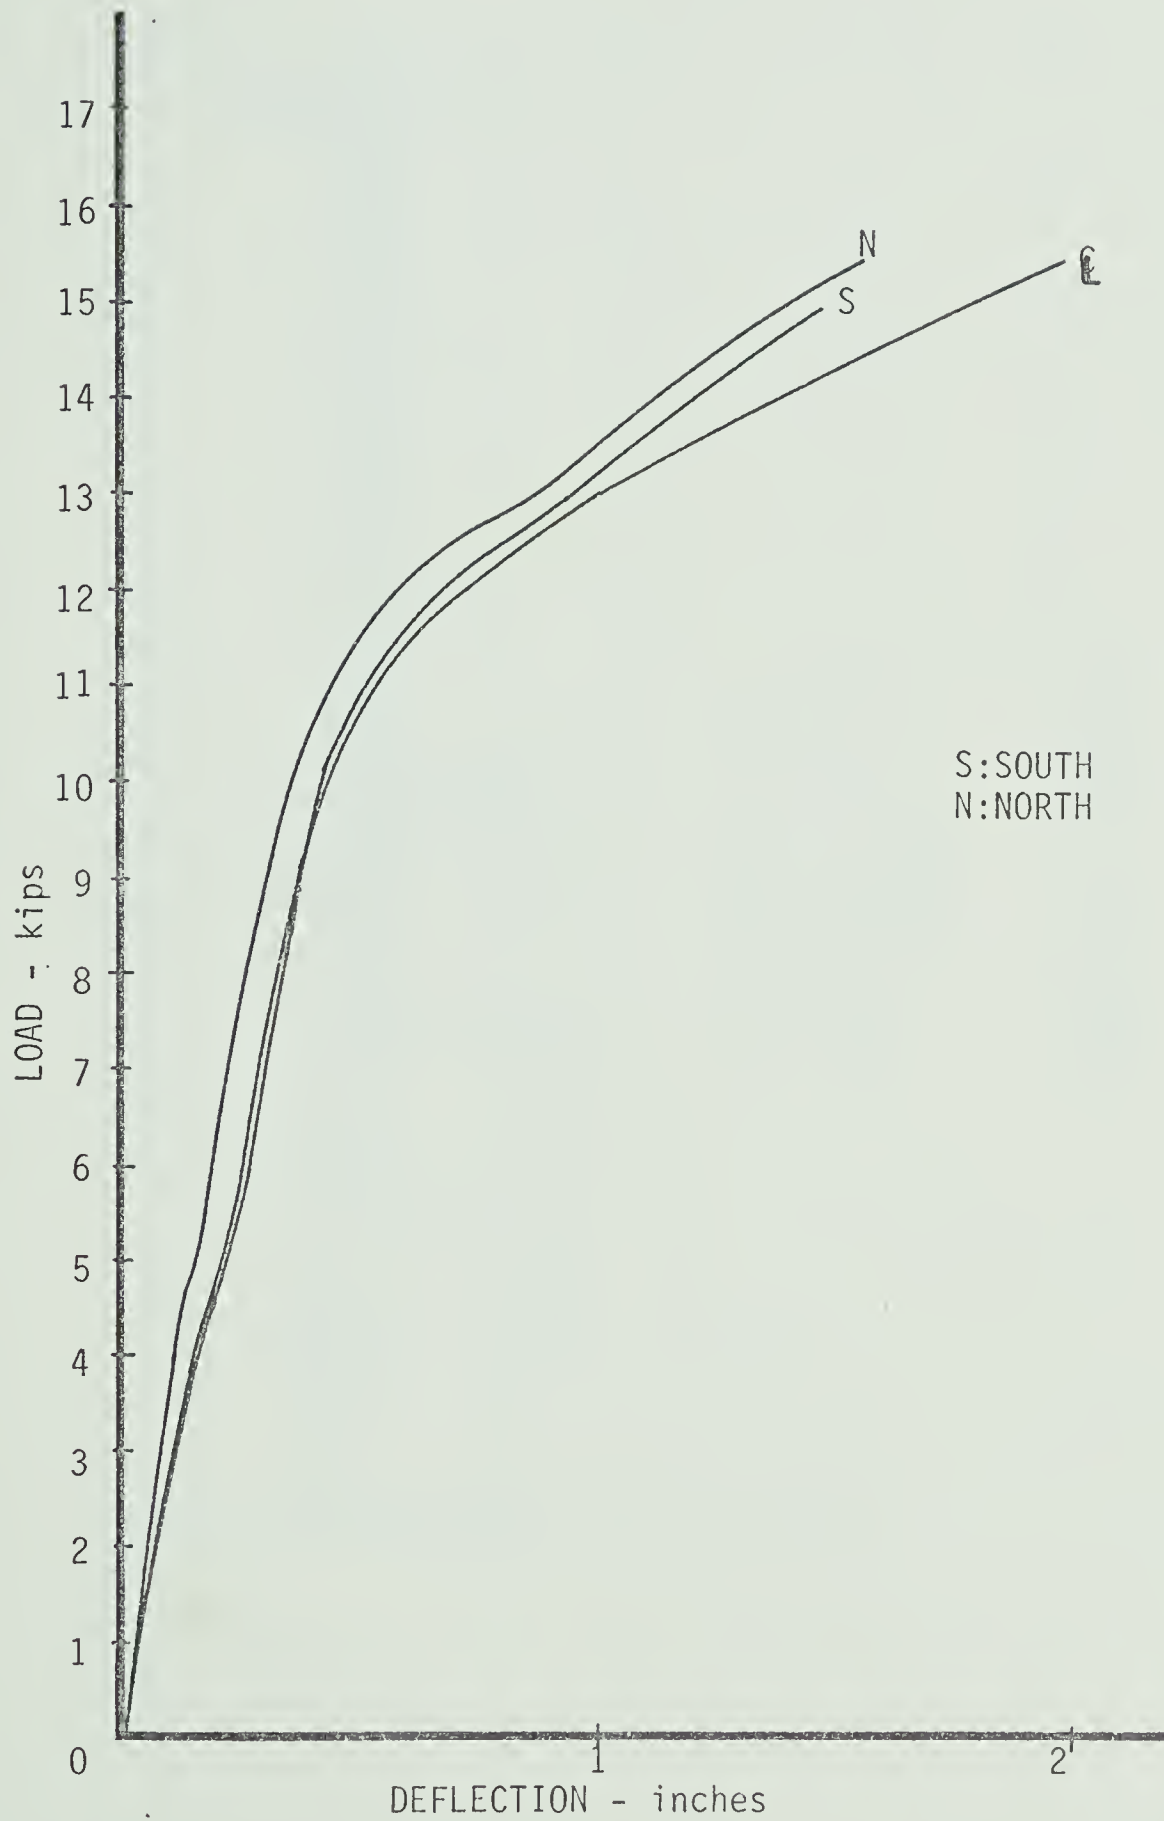
FIGURE B.7.2 LOAD DEFLECTION DIAGRAM, BEAM #7
